Restoration Report

Identification; ABNE13	Grade II listed, ID 39834
Location NGR; SU 49137 78095	West Berkshire, Parish of Beedon; A34 slip road to northern carriageway from Beedon village, inside of bend near top of slope; on grass verge
Design & material	Isley Gable – rectangular cross section, made of porous limestone with no distinct bedding planes and some inclusions
Date	Dated 1776 – some time after turnpike created

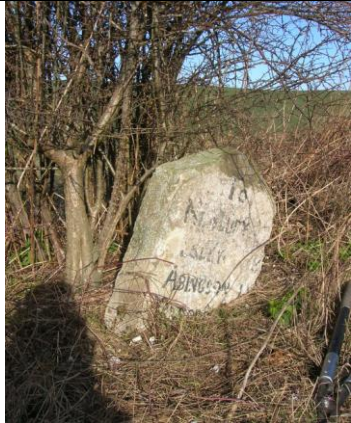
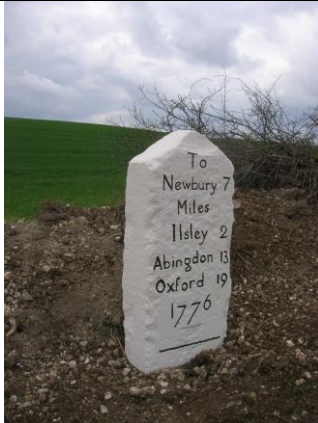
<i>Prior to Restoration</i>	<i>After Restoration</i>
Restoration work by Alan Rosevear, April 2006.

Dimension	Was 64 high above soil level	Width 45; height 98 (83 to shoulder), depth 20; letters 5.5h, number 6h
Condition of stone	Leaning to left by 25 deg and sunken so half of text obscured. Hawthorn bush at the base and overhanging. Old damage to top. Painted text does not correspond to engraving (misses Miles). On excavation found square damaged area at base (presumed to be a cancelled BM)	Excavated soil and levered stone to vertical within the existing stone filling. Ca 30cm of dressed stone remain below engraving. Large hole in lower left side (filled) and chunk taken from right side (remains). Filled hole (potentially BM pin) in top .
Condition of coating & letters	Discontinuous layer of old oil paint Black/on/white with residues of old green layer. Below this are residues of limewash on sheltered areas. Only odd letters survive near top but 1776 and lower text better preserved	Stone scraped but old oil layers needed paint stripper to remove to porous condition. Stone painted with 2 coats of 20% diluted Keim Granital and one coat of off-white Keim top coat. Letters interpolated based on odd remaining text and pattern given by ABNE14 in Beedon. Lettering painted with black Sandtex

Notes on Work	Hawthorn bush and brambles removed and area around the stone excavated and soil banked behind so it stands above new soil level. Continuous film of old paint, particularly on sides could only be fully broken with paint stripper. No need to use algicide after this. Back not stripped and left bare with odd residues of old paint. Grass seed scattered on area around stone.

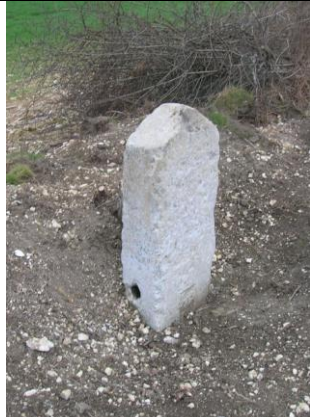
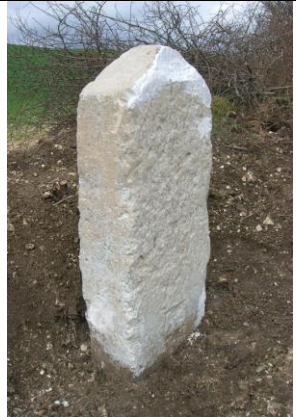
Illustrations during work

Area around stone cleared	Excavation to straighten stone	Removal of layers of oil paint	Silicate Filling to top and side
