Restoration Report

Identification; LB73	Not listed
Location NGR; SU 2087 6837	Kennet DC, Parish of Marlborough; Forest Hill; A4, London Road opp. Entrance to Marlborough Cricket & Hockey Club
Design & material	Bath Road Shoulders – rectangular block with facets cut as a slice from top corners to mid front side. Grey Limestone –reddish when wet and iron leaches out
Date	Assumed to be ca 1826 recut of a 1743 rectangular block

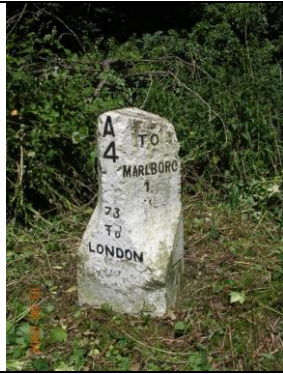
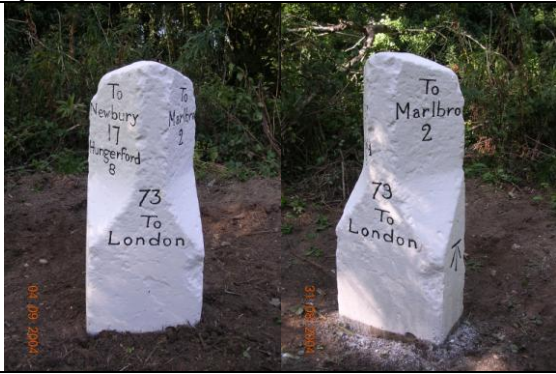
<i>Prior to Restoration</i>	<i>After Restoration</i>
Restoration work by Alan Rosevear, Aug 2004.

Dimension	Width 46; depth 29 with painted letters	Height increased to 109; engraved letters 5h, numbers 7h
Condition of stone	Stone in reasonable condition. Although still vertical, stone has sunken; chip on left side; oil paint has focused pitting on lettered areas. In deep undergrowth.	Soil cleared to make stone stand higher. No filling undertaken. Undergrowth cleared to give sight line from road.
Condition of coating & letters	Oil paint had obscured all original inscriptions. A4 painted on face. When engraving revealed, painting did not correspond to format or detailed position; Erroneous mileage to Marlborough (is 2 not 1)	Stone painted with 20% diluted Keim Granital and one coat of off-white Keim topcoat. Summer shower soon after washed off some topcoat so need a partial second topcoat. Engraving of letters followed (where feint by comparison with LB72) in black Sandtex

Notes on Work	Stone was almost invisible in undergrowth. Perennial plants and some overhanging branches removed to give good sight line. Soil was cleared and excavated for about 5m around stone to reveal original soil level of stone. . Loose layers of paint removed to reveal engraving. However, needed paint stripper to remove substantial cover of oil paint. Stone scrubbed to remove lowest layers of limewash and residual areas of oil paint scrapped away. One layer of undercoat soaked in well to give dense cover. Topcoat had to be touched up after rain shower. Lettering traced in pencil for better accuracy in painting. The engraving is like flowing text with differences in width and depth. Painting of letters could not replicate this subtlety.
