Restoration Report

Identification; HGSN06	Grade II listed, ID 310520
Location NGR; SU 2758 7427	Kennett District Council, Parish of Aldbourne, Preston, just north of old road lay-by at Alma Farm
Design & material	Swindon Half Round with base
Date	Assumed to be early 19 th century – design used on several turnpikes around Swindon so maybe commissioned by Swindon Highways Board, replacing earlier milestone

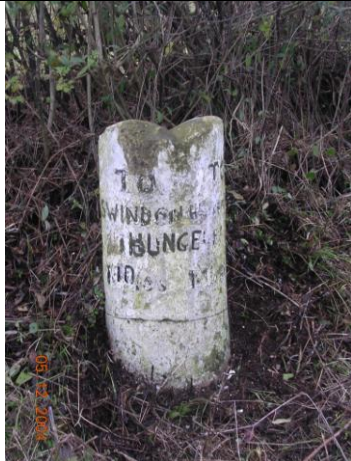
<i>Prior to Restoration</i>	<i>After Restoration</i>
Restoration work by Alan Rosevear, Jan-Mar 2005

Dimension	Stone was 73h; letters were various heights	40w by 19d by 111h; letter 5.5, 3.5 & 2.5h; numbers 7.5 & 5.5h
Condition of stone	Stone buried in old embankment. Stone has previously broken in half and has been cemented together.	Embankment dug away to expose all stone. Damage to top left and left corner face repaired with Silicate filler. Surface imperfections not treated.
Condition of coating & letters	Shallow thin carving with script differences in width. Benchmark on front. Multiple layers of oil-based paint have obscured engraving and black lettering has been painted at several places	Oil paint layers removed with paint stripper to restore to porous clean stone. Stone painted with 2 coats of 20% diluted Keim Granital and one coat of off-white Keim topcoat. Letters painted in black Sandtex

Notes on Work	Considerable amount of excavation needed to make stone freestanding and visible. Needed several paint stripper treatments to remove all layers and reveal original engraving. Stone almost clear of paint and lime residues after repeated scrubbing with soapy water using wire brush and then scrubbing brush. Smaller letters eroded badly. Back left bare.
