## Restoration Report

<b>Identification; LBF71</b>	Not listed
Location NGR; SP 27963 94995	Vale of White Horse, Parish of Great Faringdon; Highworth Road; opp. Highways Depot; on wide well kept grass verge, near town boundary sign
Design & material	Highworth Old London Road – rectangular cross section, Made of porous limestone with no bedding planes
Date	Assumed to be ca 1750 based on turnpike Act, Roman numerals and shape of letters

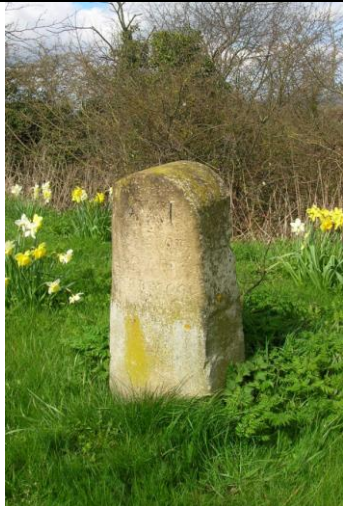
<i>Prior to Restoration</i>	<i>After Restoration</i>
Restoration work by Alan Rosevear, April 2006.

Dimension	Dimensions unaltered	width slopes from 35 at top to 41 at base; cut from rectangular stone 47 x 17; letters 5h, number 6h
Condition of stone	Erect and at correct height, but heavy covering of lichen, particularly on lower parts. Some cracks and voids at ground level.	Cleaned and scraped to remove lichen and residual paint. Cracks at base filled with silicate but surface imperfections not treated.
Condition of coating & letters	Clear incised letters and numbers, though incisions are shallow. Gothic script uses different depths on risers and fallers. Rough area from presumed defaced bench mark on right side. Discontinuous layer of old oil paint Black/on/white with residues of old green layer. Old lime persists within the inscriptions.	Scrubbed with brush with scrubber and wire brush – last of lichen removed with scraper. Persistent layers of paint on sides removed by scrubbing. Treated with algicide to kill residual lichen. Stone painted with 2 coats of 20% diluted Keim Granital and one coat of off-white Keim top coat. Back left bare. Letters painted in black Sandtex

Notes on Work	Weeds against stone cleared but in a good grass setting so no site work required. Back not stripped so left some old paint and an area where paint had caused stone to delaminate.
